Duropack Belisce d.d. (Croatia) assigned AS Drives & Services GmbH as a main contractor, to modernize the drive technology

At the end of September 2013, the first step of the rebuild at Duropack Belisce (Croatia) took place. The main targets of the rebuild were to speed up the PM 2 and to reduce maintenance expenses of the drive and lubrication technology. The company AS Drives & Services GmbH performed the rebuild as a main contractor together with the cooperation partner Kühne + Vogel Prozessautomatisierung Antriebstechnik GmbH. Eight months after the rebuild Mr. Dejan Brkic (mech. eng. Head of maintenance department) Duropack was asked, how the course of project was and what has changed since then.

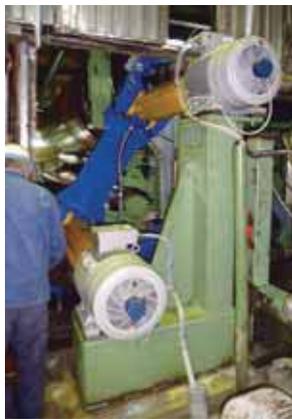
Fig. 2: Single Drive with FlexoGear® and torque support

D. Brkic: Especially the flexibility of the gear box solution FlexoGear® from AS convinced us. The gearboxes are only mounted on the cylinder journal and support each other with a special torque support. We can drive up to two gearboxes and two cylinders with only one motor with the selected solution. Alternatively, we can drive critical cylinders separately, while using the same torque support.

(See picture). We only need one FlexoGear®-gearbox as a spare part. The spare FlexoGear® can be installed at any position, due to the similar design of all installed FlexoGear® gearboxes. The control of the multiple motor drives should be done completely by the company K+V and should lead to a smooth run and counteract the sheet flutter. We see the advantage of the central lubrication unit Lubriflex® from AS in

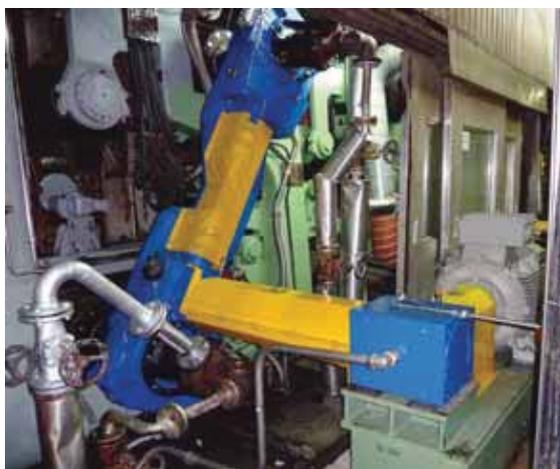
Fig. 2: FlexoGear® Duo-Version

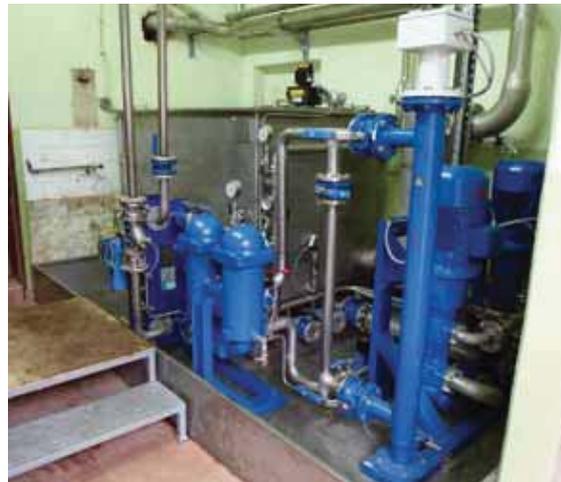
Fig. 4: Central lubrication Unit Lubriflex®

the special degassing and cleaning system. In addition, the Lubriflex® can heat up or cool down the oil, so that the oil got the right temperature at any time. In this way, we can slowly heat up the oil in the start-up phase. Finally, we decide us for the flow meter FlexoFlow®, because they adjust themselves fully automatically. All required information will be provided to the PLC. The control effort will be reduced to a minimum, because the FlexoFlow® will control the lubrication points simultaneous and independently.

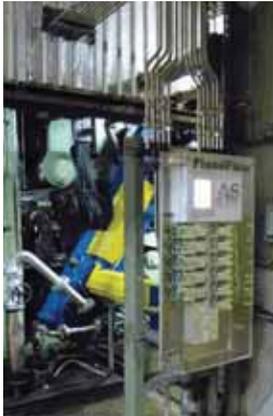
Fig. 5: FlexoFlow® Terminal outside of the drying hood for the oil supply

us. Now we have better information as well as the control of all lubrication points and the overall system performance. An extra advantage is that the FlexoFlow®s are installed outside of the drying hood. We very appreciate this easy to maintain solution. A further major advantage of the new sectional drive control is the scalability and expandability of the modular WebDrive+/Paper control system. Even the remaining old drives of the machine have already been integrated into the new control architecture, so that future step-by-step rebuilds of all other drives are easily achievable and affordable.
